Guidance for Cultural Resources Management for the U.S. Army Installations in Korea

Volume II: The 2nd Planning Level Survey (PLS)

Final Report – October

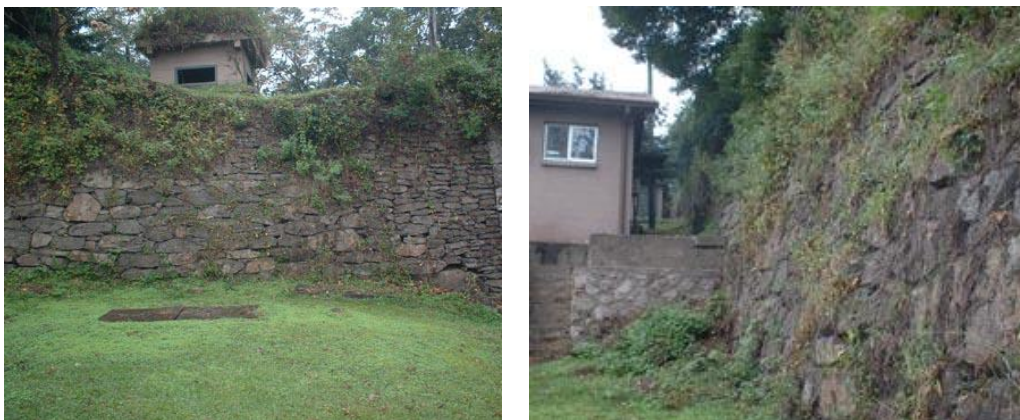
Figure 3.11. Remains of Seoul City Wall at Camp Morse

A part of the Seoul City Wall was identified near buildings S-26, S-21 and S-47. The Seoul City Wall was built between 1396 and 1397 for the protection of the capital city of the Chosun dynasty (1392-1910). The wall surrounded the core areas of today's Seoul. It stretched almost 17 kilometers (about 10.1 miles) connecting four mountains: Mt. Namsan, Mt. Inwangsan, Mt. Bugaksan and Mt. Naksan. The original wall was kept intact until 1915 when Japanese colonial military destroyed most of the gates and many parts of the wall, especially the portions located at lower elevations.

The wall is of significant cultural value. The remaining parts of the wall in Seoul are currently designated as National Historic Site Number 10. However, the wall remains in Camp Morse are currently excluded because the Korean authority is not aware of the remains within the installation boundaries.

The wall found at the installation is about 2.0 to 2.2 meters in height and approximately 20 meters in length. Unfortunately the original shape of the wall was severely damaged. Some parts of the wall surface were reinforced with cement. In addition, some stones that were removed from the wall, were used for construction of nearby bunkers and/or fences.

- A signboard is recommended to increase awareness of the wall.
- Maintenance or construction personnel who encounter any cultural resources should need to immediately notify the ACoS, Engineer through the installation commander according to USFK-EGS Art. 12-3. Upon encountering the resources, the personnel should stop any activity that might result in adverse effects to the resources until appropriate mitigation or transfer is completed.
- In-depth assessment is recommended for the site.

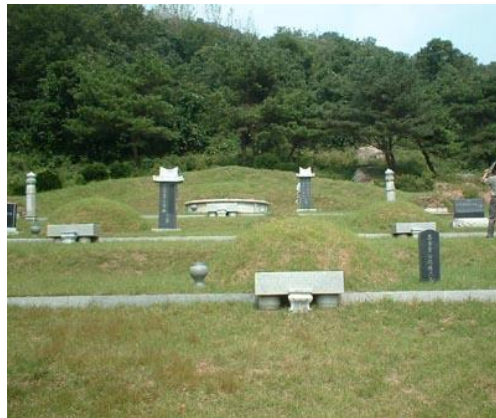
Figure 3.12. Five graves of Jo family near hole #12

The five graves were observed to the north of hole #12. Inscriptions on the tombstones indicate that the graves belong to the Jo family. Although they are recent burials with less historic value, their existence needs to be noted and inventoried.

- Maintain the current condition of the grave.

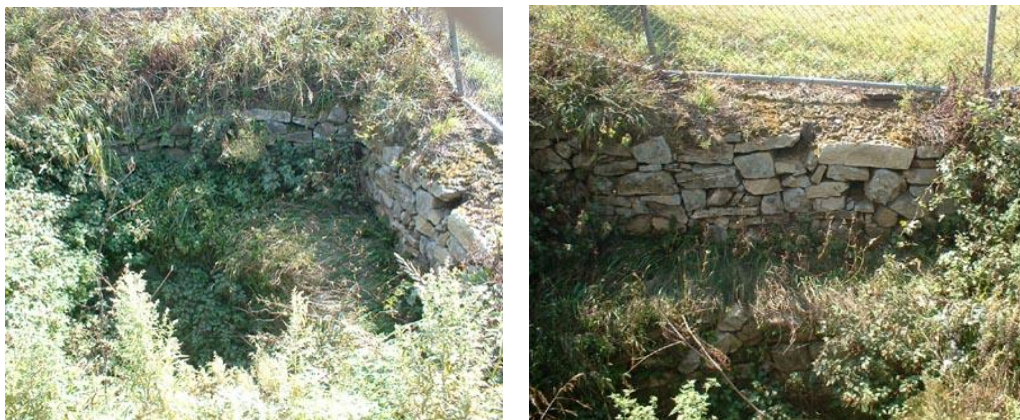
Figure 3.13. A well-shaped stone structure within Koryosan Army Security Agency

During the survey, a stone structure that appears to be a well was found (figure 3.13) on the summit of the mountain. The structure is sunken into the ground. Fences have been set around the area to prevent any accidents. Due to the tall fence and heavy weed cover, closer observation of the structure was not possible. It is evident, that this is a man made structure of historical significance.

- In-depth assessment is recommended.

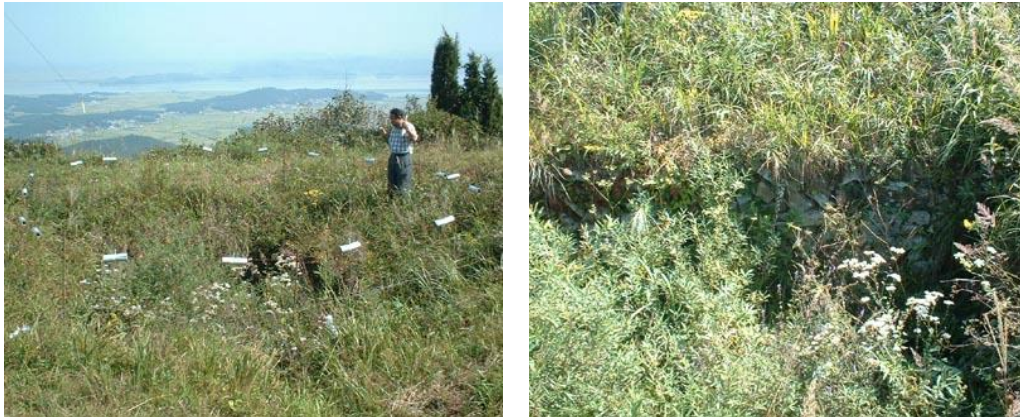
Figure 3.14. A well-shaped stone structure outside Koryosan Army Security Agency

Another similar structure was found on the northern slope of the mountain, approximately 50 meters from the camp perimeter (figure 3.14). The layout and structure is almost identical to the one found inside the camp. The inner structure was difficult to observe due to thick vegetation covering.

It appears to have a rectangular structure, each side measuring approximately 20 feet. From the surface, stone lines form the vertical walls rising up several feet, forming the upper part of the structure. As the structure descends below the ground surface, the shape

changes to a round structure. This extends downwards approximately 10 feet.

The remnants of the stone wall-like structure can only be seen in certain locations, which suggest that the summit was exploited at some point in the past and that the well-like structure could be one of the facilities that once existed there.

According to local traditions, there were five wells known as Oyonji, literally meaning Five Lotus Ponds. It is estimated that these two structures might be a part of Oyonji. Since no material or written evidence to suggest their origin could be found, it is difficult to determine what these structures were for and when they were made. Similar structures are found at many other places in Korea, all of which are related to defensive facilities during the time.
